Job title: Aldi Eastbourne

Report type: SuDS Appraisal

Prepared for: Aldi Stores Ltd

Date: March 2022

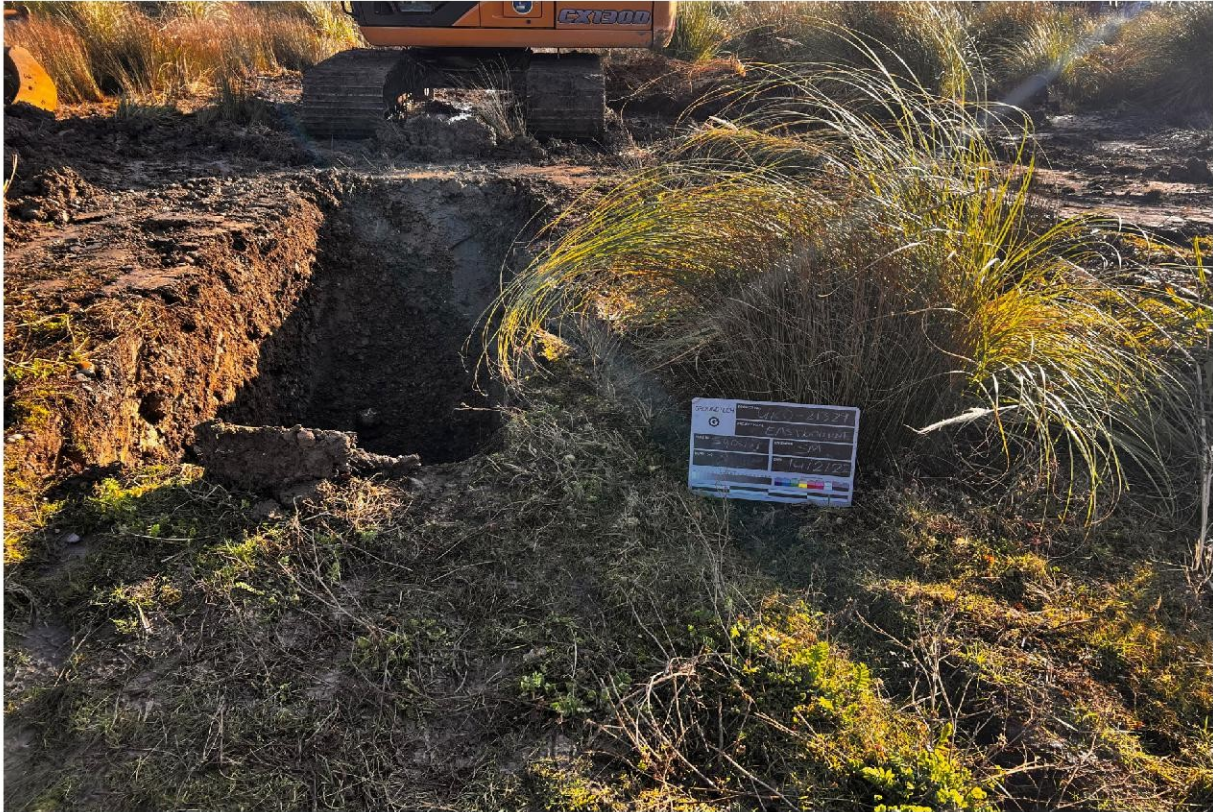
Photograph 1 – SuDS101

The results of the soil infiltration tests carried out in SuDS101 to SuDS103 indicate very poor drainage conditions exist at these locations and depths with infiltration rates of 0.0m/s being recorded. These tests were carried out in the Clay deposits soils at depths of between 1.7m and 2.0m bgl.
